# Manhole Inspection Summary

Manhole # S43II\_031MH

Insp Date: **3/1/10 1:38 PM**

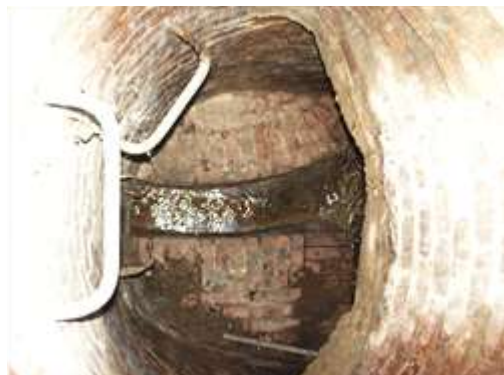
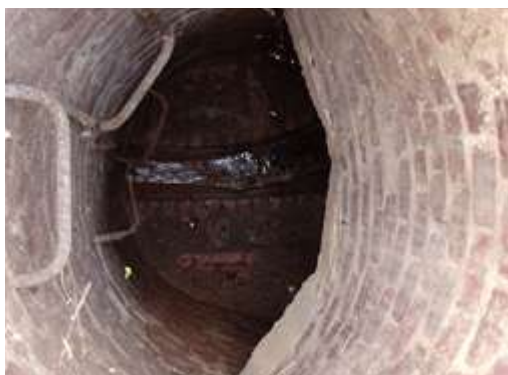
Top View

Condition: ☐ Sound ☐ Cracked ☐ Root Intrusion ☒ **Loose Brick** ☐ Deteriorated

**Steps** Count: **5** Missing: **1** ☒ **Corroded**

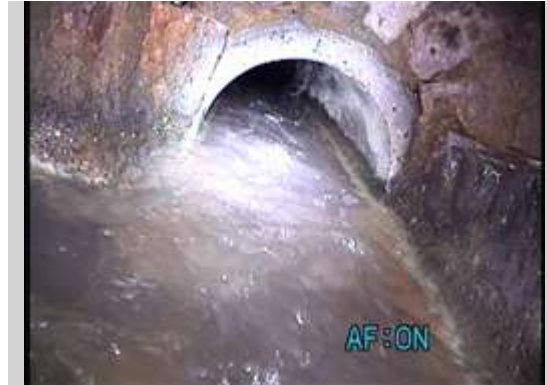
12 O'Clock Outflow  
Pipe Out @ 12 O'Clock

Pipe Height: **12** (in.) Rod and Bar (Angled)  
Pipe Material: **Clay** ☐ Pipe Lined  
Invert Depth: **9.58** (ft.) Flow Characteristics: **Fast**  
Deposits: ☒ None ☐ Mud ☐ Sludge ☐ Debris ☐ Grease  
Silt Depth: (in.) Deposits Extent:  
Infiltration: **None** Pipe Seal Cond: **Sound**

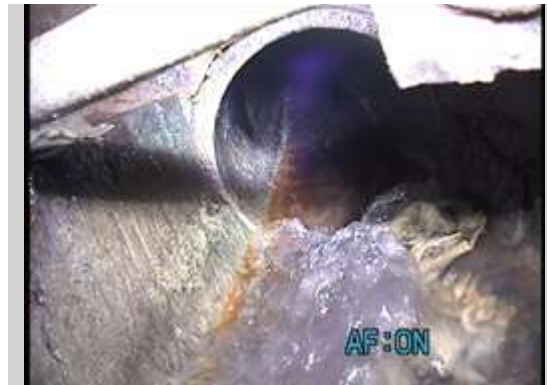
6 O'Clock Inflow  
Pipe In @ 6 O'Clock

Pipe Height: **12** (in.) Rod and Bar (Angled)  
Pipe Material: **Clay** ☐ Pipe Lined  
Invert Depth: **9.83** (ft.) Flow Characteristics: **Fast**  
Deposits: ☒ None ☐ Mud ☐ Sludge ☐ Debris ☐ Grease  
Silt Depth: (in.) Deposits Extent:  
Infiltration: **None** Pipe Seal Cond: **Sound**
